Valve Tappet Clearance Adjustment

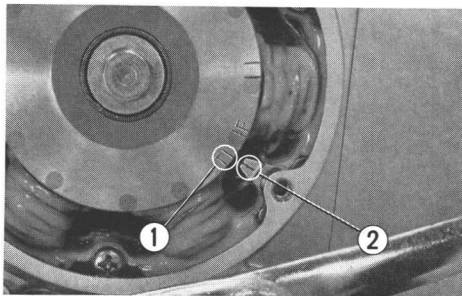
1. Remove the generator cover and tappet adjusting hole caps.
2. Rotate the generator rotor counter-clockwise until the "T" mark ① on the generator rotor lines up with the index mark ② on the stator.

① "T" mark

② Index mark

Valve tappet clearance is checked with the engine cold.
