Lights / instruments / switches

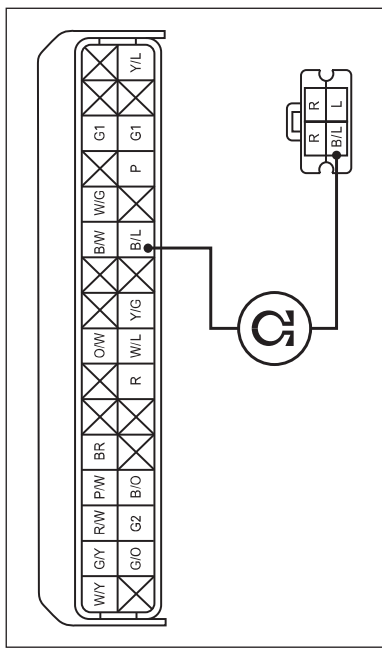
Wire harness inspection

Check for continuity of the Black/Blue wire between the fan motor relay 2P (Natural) connector and ECM 32P (Black) connector. There should be continuity. If there is no continuity, repair or replace the wire harness.
