Wear Inspection:

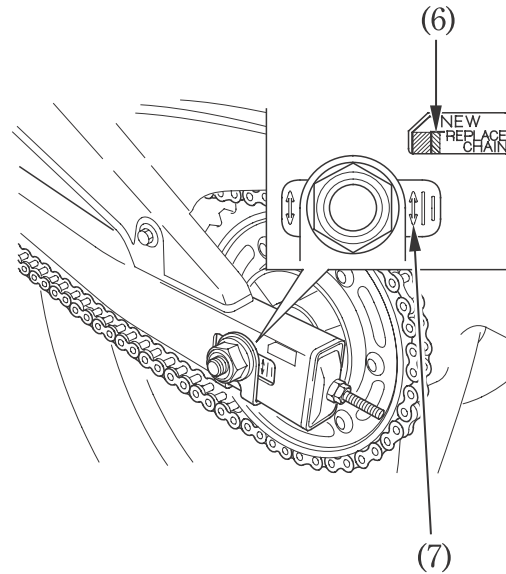
Check the chain wear label when adjusting the chain. If the red zone (6) on the label aligns with the arrow mark (7) on the chain adjuster plates after the chain has been adjusted to the proper slack, the chain is excessively worn and must be replaced. The proper slack is:

- (6) Red zone
- (7) Arrow mark
