Chapter lights / instruments / switches (2ED)

**Wire harness inspection**

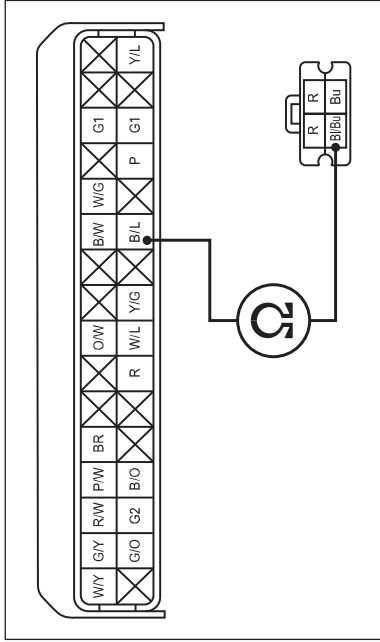
Check for continuity of the Black/Blue wire between the fan motor relay 2P (Natural) connector and ECM 32P (Black) connector. There should be continuity. If there is no continuity, repair or replace the wire harness.
