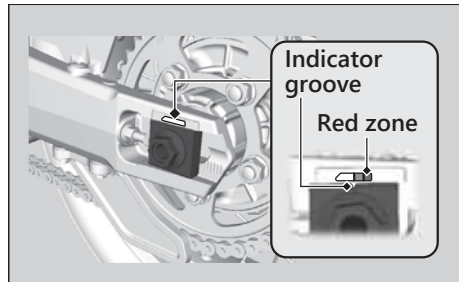
Check the chain wear label when adjusting the drive chain. If the indicator groove on the adjusting plate enters the red zone on the label after the chain has been adjusted to the proper slack, the chain is excessively worn and must be replaced.

Chain: DID 525HV3
