Accelerator Pedal

Accelerator Pedal Inspection

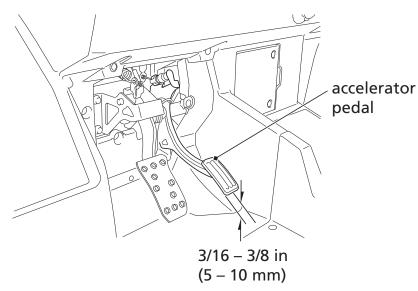
Check freeplay of the accelerator pedal.

Freeplay:

3/16 - 3/8 in (5 - 10 mm)

Your Honda SXS is equipped with an accelerator pedal position sensor. When the openings of the accelerator pedal and throttle valve do not match, the PGM-FI Malfunction Indicator Lamp (MIL) comes on and limits the vehicle to a safe controllable speed. If the accelerator pedal has excessive play due to cable stretch or incorrect adjustment, the openings of the accelerator pedal and throttle valve will not match.
