Electrical servicing

Lights / instruments / switches

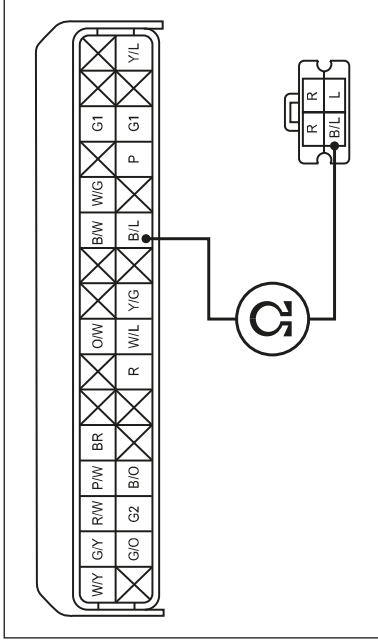
Wire harness inspection

Check for continuity of the Black/Blue wire between the fan motor relay 2P (Natural) connector and ECM 32P (Black) connector.

There should be continuity.
If there is no continuity, repair or replace the wire harness.
